# Pacific Pro Home Inspection

## Property Inspection Report

Client(s): **Larry Rimes**  
Property address: **225 19th St. Port Orford**  
Inspection date: **Tuesday, June 10, 2014**

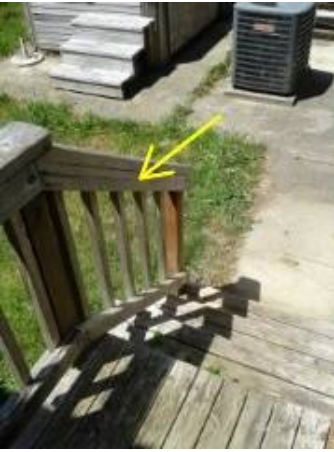
Handrails at one or more flights of stairs were missing. This is a potential fall hazard. Handrails should be installed at stairs with four or more risers or where stairs are greater than 30 inches high. Recommend that a qualified contractor install handrails where missing and per standard building practices.

**Photo 2-1**  
No hand grab on four riser stairs.

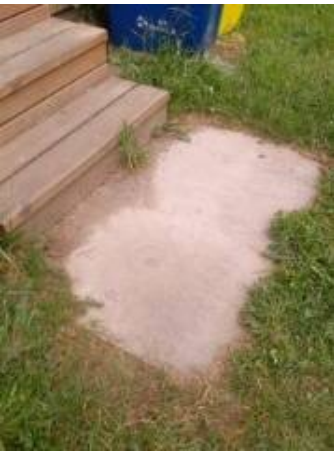
**Photo 3-1**

Significant amounts of standing water or evidence of past accumulated water were found at one or more locations in the yard or landscaped areas, and no drain was visible. If evidence of past water was found (e.g. silt accumulation or staining), monitor these areas in the future during periods of heavy rain. If standing water exists, recommend that a qualified person repair as necessary. For example, installing one or more drains, or grading soil.

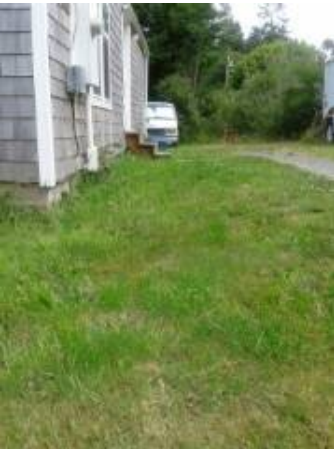
## Photo 4-1

The soil or grading sloped down towards building perimeters in one or more areas. This can result in water accumulating around building foundations or underneath buildings. It is a conducive condition for wood-destroying organisms. Recommend grading soil so it slopes down and away from buildings with a slope of at least 1 inch per horizontal foot for at least 6 feet out from buildings.

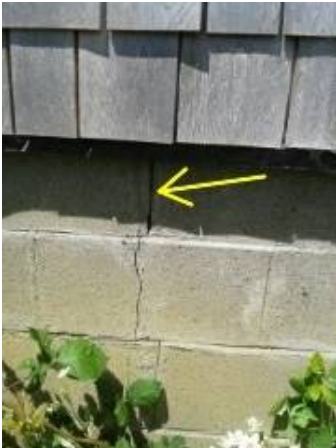
Moderate cracks (1/8 inch - 3/4 inch) and/or leaning were found in the foundation. This may be a structural concern or an indication that settlement is ongoing. The client should consider hiring qualified contractors and/or engineers as necessary for further evaluation. Such contractors may include:

**Photo 5-1**  
Crack in cinder block stem wall.

At a minimum, recommend sealing cracks to prevent water infiltration. Numerous products exist to seal such cracks including hydraulic cement, resilient caulks and epoxy sealants.

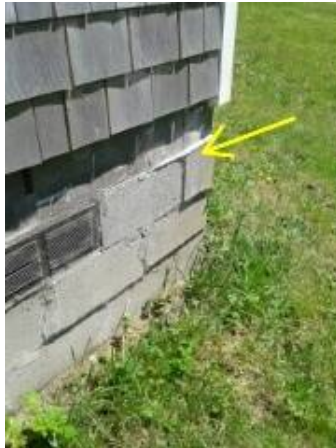
**Photo 5-2**  
Poor workmanship in laying block foundation

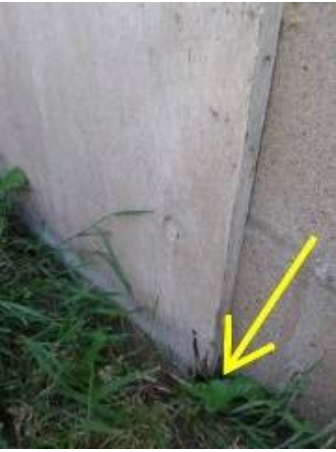
**Photo 6-1**  
Crawl space access door in contact with ground. Wood to ground contact creates an environment conducive to wood destroying organisms.

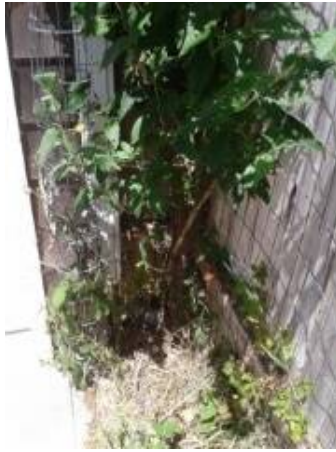
Vegetation such as trees, shrubs and/or vines was in contact with or close to the building exterior. Vegetation can serve as a pathway for wood-destroying insects and can retain moisture against the exterior after it rains. This is a conducive condition for wood-destroying organisms. Recommend pruning, moving or removing vegetation as necessary to maintain at least 6 inches of space between it and the building exterior. A 1-foot clearance is better.

**Photo 6-2**  
Brush growing against siding.

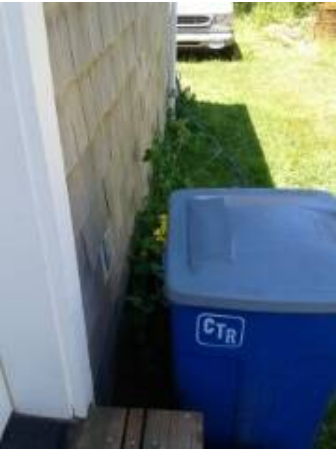
**Photo 6-3**  
Blackberries growing under siding.

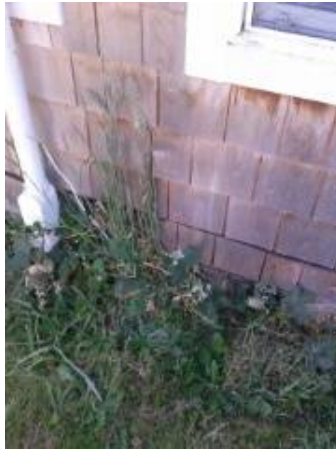
**Photo 6-4**  
Vegetation against siding

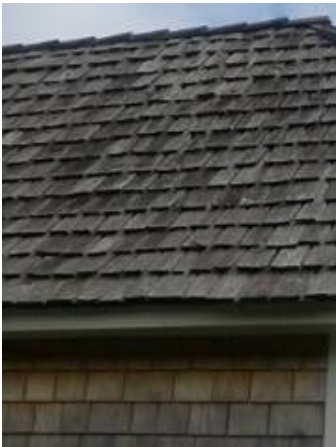
Photo 9-1

Many wood shakes or shingles were deteriorated. Leaks can occur as a result. This is a conducive condition for wood-destroying organisms. Recommend that a qualified contractor repair as necessary. For example, by replacing or fastening shakes or shingles, or installing flashing.

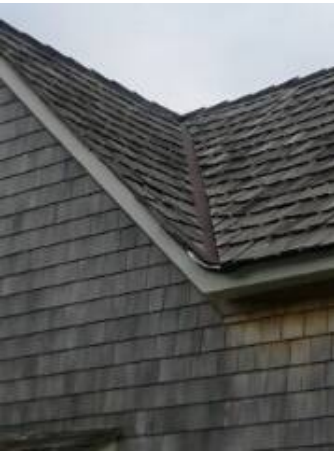
Photo 10-1

One or more roof flashings were corroded. Leaks can occur as a result. This is a conducive condition for wood-destroying organisms. Recommend that a qualified person repair as necessary.

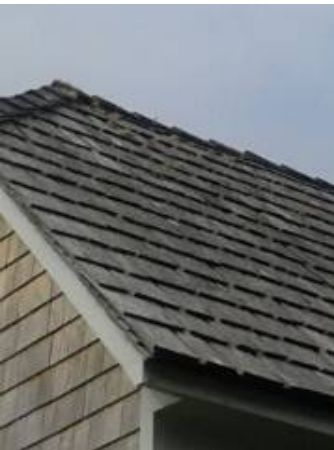
Photo 11-1

Moss was growing on the roof. As a result, shingles can lift or be damaged. Leaks can result and/or the roof surface can fail prematurely. Efforts should be made to kill the moss during its growing season (wet months). Typically, zinc or phosphate-based chemicals are used for this and must be applied periodically. For information on various moss treatment products and their pros and cons, visit:

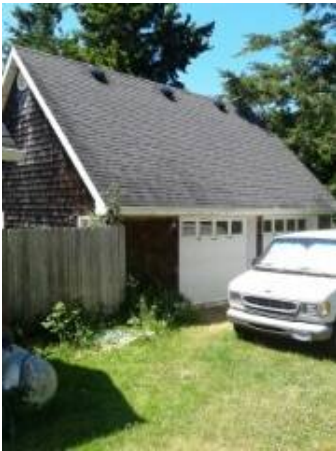
The attic access hatch in the garage was blocked by a vehicle or stored items. The inspector was unable to enter, view or traverse the attic space over the garage. This area is excluded from this inspection.

**Photo 14-1**  
Garage.

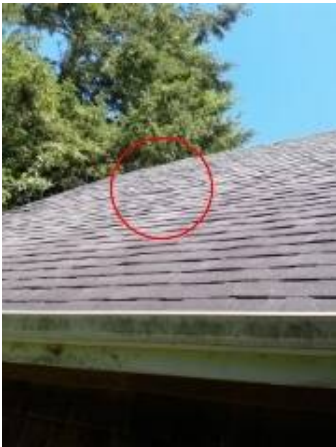
**Photo 15-1**

Some composition shingles were damaged. Leaks can occur as a result. This is a conducive condition for wood-destroying organisms. Recommend that a qualified contractor repair as necessary. For example, by replacing shingles.

Area on west side where shingles have lifted

Raised area of composition shingles on garage roof.

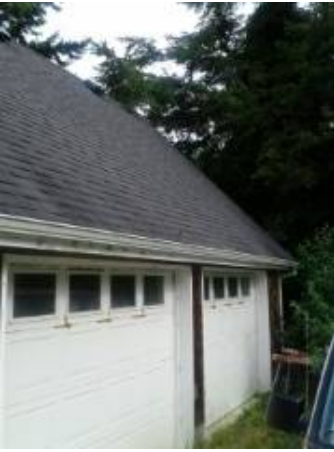
Photo 16-1

Significant amounts of debris have accumulated in one or more gutters or downspouts. Gutters can overflow and cause water to come in contact with the building exterior, or water can accumulate around the foundation. This is a conducive condition for wood-destroying organisms. Recommend cleaning gutters and downspouts now and as necessary in the future.

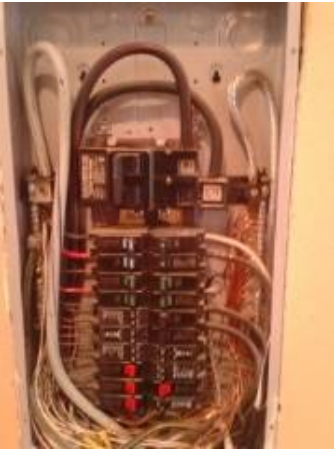
Neutral and ground wires did not appear to be bonded together at the main service panel. In the main service panel, neutrals and grounds should be connected (bonded) to each other and to the metal panel housing. This is a safety hazard for shock. Recommend that a qualified electrician evaluate and repair per standard building practices.

**Photo 17-1**  
Main Electrical panel

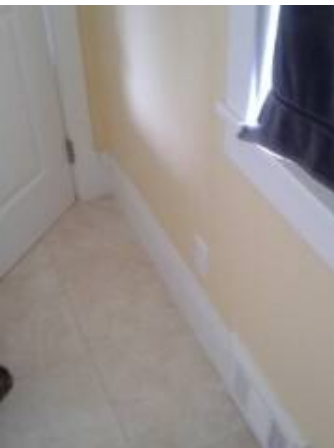
**Photo 18-1**

One electric receptacle (outlet) at the bathroom had no visible ground fault circuit interrupter (GFCI) protection. If not GFCI-protected, receptacles in wet areas pose a shock hazard. Recommend that a qualified electrician evaluate and install GFCI protection if necessary and per standard building practices. General guidelines for GFCI-protected receptacles include the following locations:

Bathroom lower receptacle not gfci and is within 6 feet of sink.

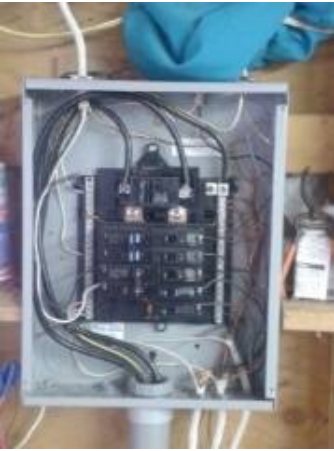
Photo 19-1

Neutral and equipment ground wires were bonded (connected) at sub-panel(s) # C. This should only occur in the main service panel, not sub-panels, and is a shock hazard. Neutral wires should be attached to a "floating" neutral bar not bonded to the panel, and grounding wires should be attached to a separate grounding bar bonded to the sub-panel. Recommend that a qualified electrician repair per standard building practices. For more information, visit:  
<http://www.reporthost.com/?SUBGRND>

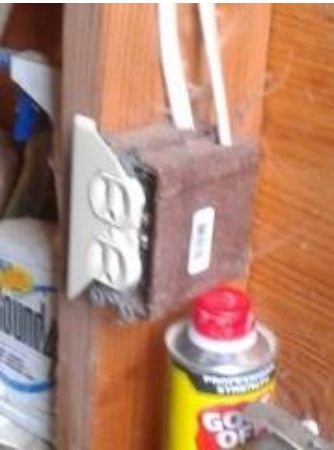
Photo 20-1

One receptacle (outlet) in the garage was broken or damaged. This is a potential shock or fire hazard. Recommend that a qualified electrician replace such receptacles as necessary.

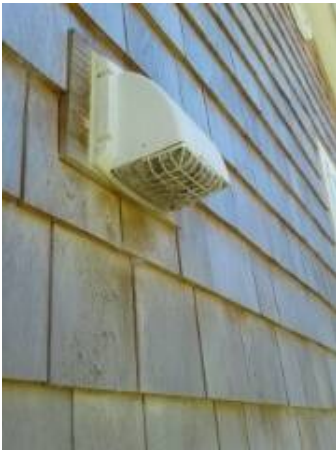
The propane tank's filling connection and/or liquid level gauge were located less than 10 feet from a source of ignition (e.g. clothes dryer vent, water heater or furnace exhaust, heat pump or AC compressor unit, intake to direct vent appliance, electric receptacle). This is a potential explosion or fire hazard. Recommend that a qualified contractor make modifications per standard building practices to eliminate this hazard. For example, by moving the tank or the source of ignition.

**Photo 23-1**  
Dryer vent clogged and directly above propane tank.

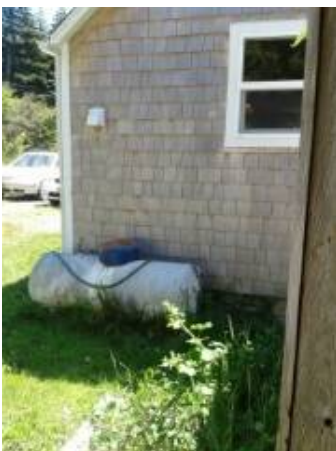
The pressure regulator for the gas service was too close to an opening into the building. Small amounts of gas can vent from regulators from time to time, so regulators should be located at least 3 feet from building openings, although this distance varies depending on the municipality. This is a potential explosion and fire hazard. Recommend that a qualified contractor repair as necessary. For example, by installing a pipe extension onto the regulator.

**Photo 24-1**  
Propane tank against house

within three feet of opening and directly below dryer vent.

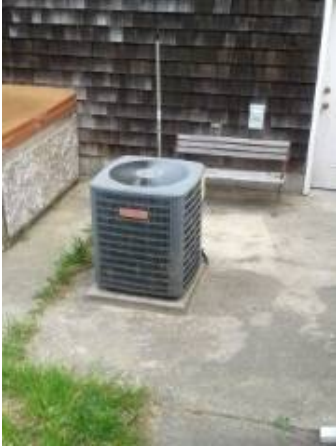
Photo 27-1

The heat pump or air conditioner condensing unit was not fully evaluated because it was not hooked up. The existing air handler was hooked up to operate as an forced air furnace only. Recommend that a full evaluation be made by a qualified person when

conditions have been corrected so the system is operable. Note that the inspector does not operate or replace overcurrent protection devices, or operate any controls other than normal controls (thermostat).

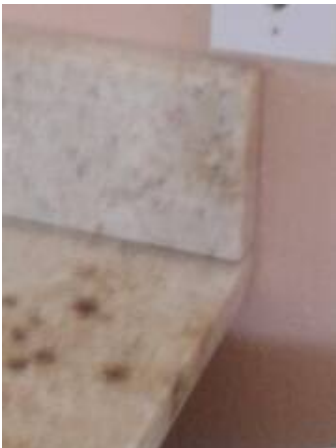
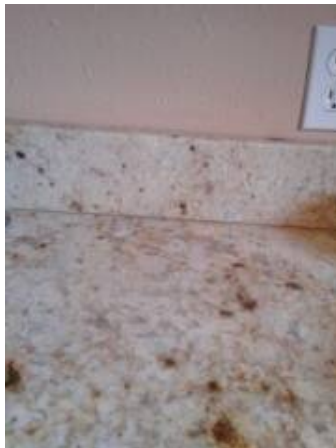
Gaps, no caulk, or substandard caulking were found between countertops and backsplashes. Water may penetrate these areas and cause damage. Recommend that a qualified person repair as necessary. For example, by installing caulk.

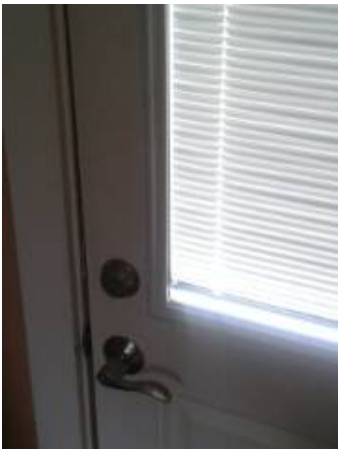
Photo 29-1

One or more exterior doors had double-cylinder deadbolts installed, where a key is required to open them from both sides. This can be a safety hazard in the event of an emergency because egress can be obstructed or delayed. Recommend replacing double-cylinder deadbolts with single-cylinder deadbolts where a handle is installed on the interior side.
