Pacific Pro Home Inspection

Property Inspection Report

Property address: **Urban**

Inspection date: **Sunday, June 29, 2014**

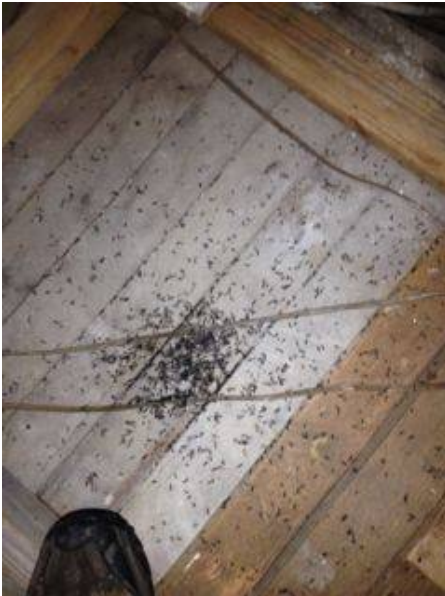
Photo 1-1

Evidence of rodent infestation was found in the form of feces in the attic. Consult with the property owner about this. A qualified person should make repairs to seal openings in the structure, set traps, and clean rodent waste as necessary. Recommend following guidelines in these Center for Disease Control articles:

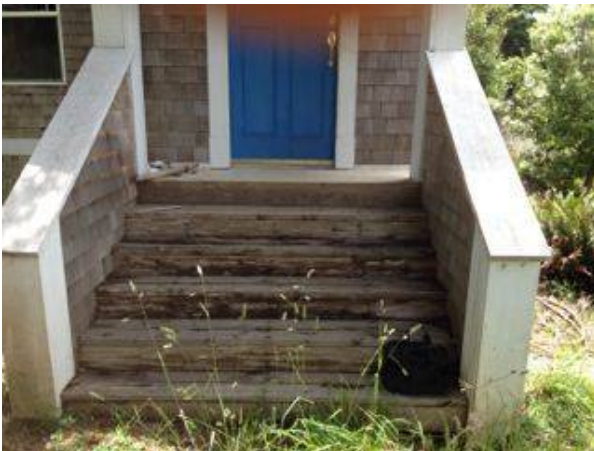
Photo 5-1

Handrails or grabs at the front flight of stairs were missing. This is a potential fall hazard. Handrails should be installed at stairs with four or more risers or where stairs are greater than 30 inches high. Recommend that a qualified contractor install handrails where missing and per standard building practices.

Soil was in contact with or close to wooden stairs at one or more locations. This is a conducive condition for wood-destroying organisms. Soil should be graded and/or removed so no wood-soil contact is present, if possible. Otherwise, installing products such as borate-based Impel rods may help to prevent infestation and damage. For more information, visit:

Wood in contact with soil and no hand grab for the stairs.

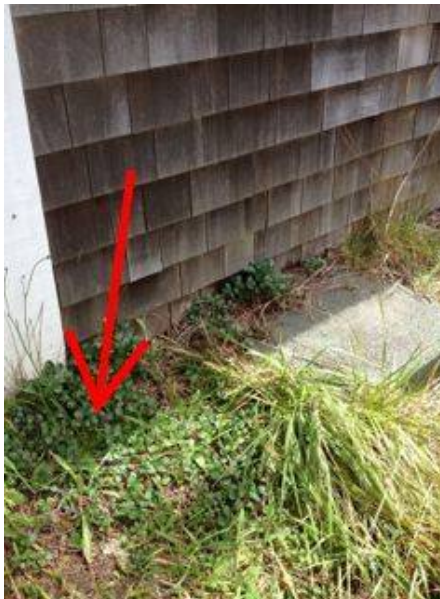
Photo 5-2

Siding in contact with soil

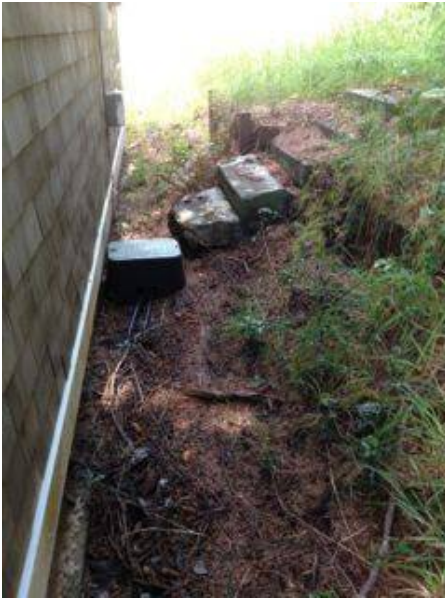
**Photo 6-1**

Old retaining wall failing. Client should verify existence of perimeter drain with owner.

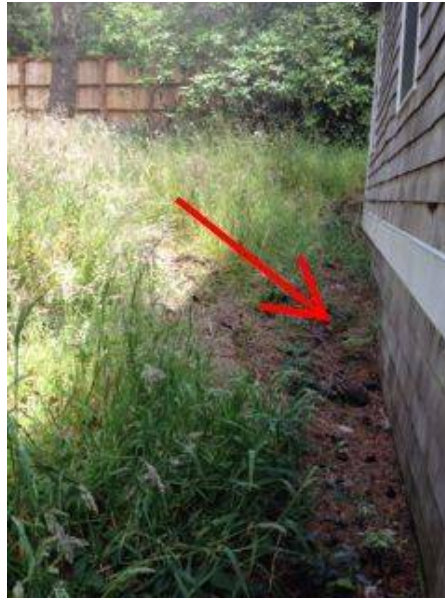
**Photo 6-2**

The soil or grading sloped down towards building perimeters in one or more areas. This can result in water accumulating around building foundations or underneath buildings. It is a conducive condition for wood-destroying organisms. Recommend grading soil so it slopes down and away from buildings with a slope of at least 1 inch per horizontal foot for at least 6 feet out from buildings.

Grade sloping toward foundation.

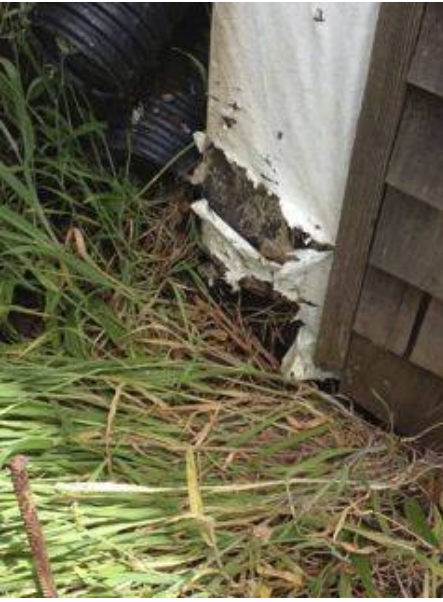
Photo 9-1

Soil was in contact with or less than 6 inches from siding, trim or structural wood. This is a conducive condition for wood-destroying organisms. Recommend grading or removing soil as necessary to maintain a 6-inch clearance. If not possible, then recommend replacing untreated wood with pressure-treated wood. Installation of borate-based products such as Impel rods can also reduce the likelihood of rot or infestation if soil cannot be removed. Note that damage from fungal rot and/or insects may be found when soil is removed, and repairs may be necessary.

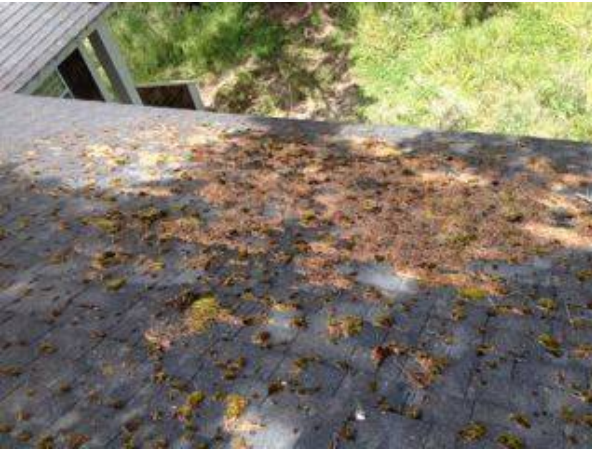
Photo 17-1

Significant amounts of debris such as leaves, needles, seeds, etc. have accumulated on the roof surface. Water may not flow easily off the roof, and can enter gaps in the roof surface. Leaks can occur as a result. This is a conducive condition for wood-destroying organisms. Recommend cleaning debris from the roof surface now and as necessary in the future.

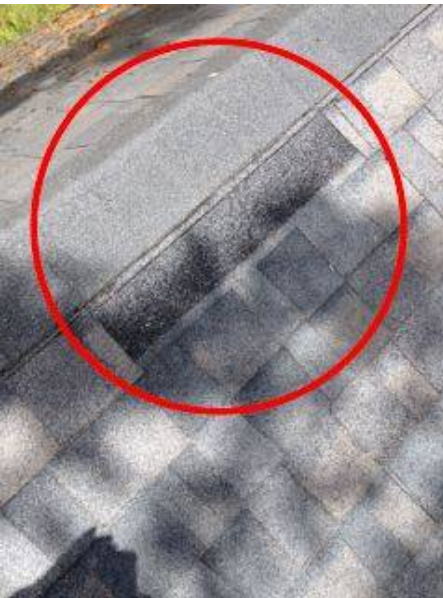
Photo 19-1

Missing a shingle here.

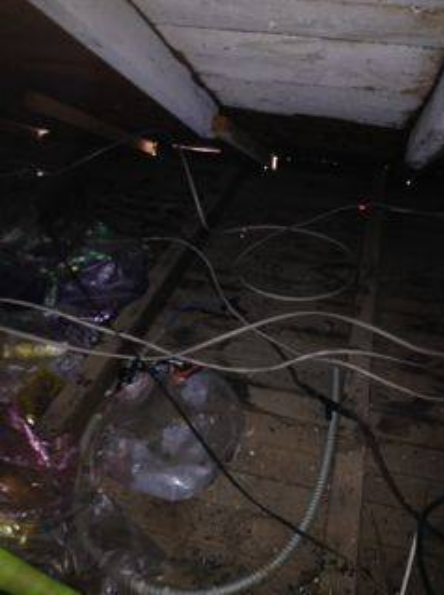
Photo 20-1

Loose cables and two open electrical receptacles (one near hatch) are an safety issue.

Electrical cables not secured in attic to joists.

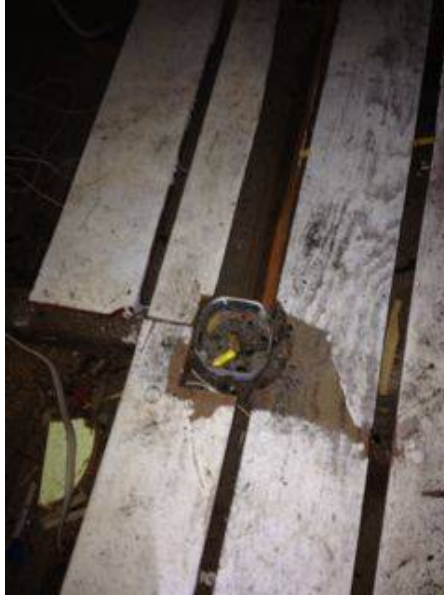
Photo 20-2

Open electrical receptacle in attic.

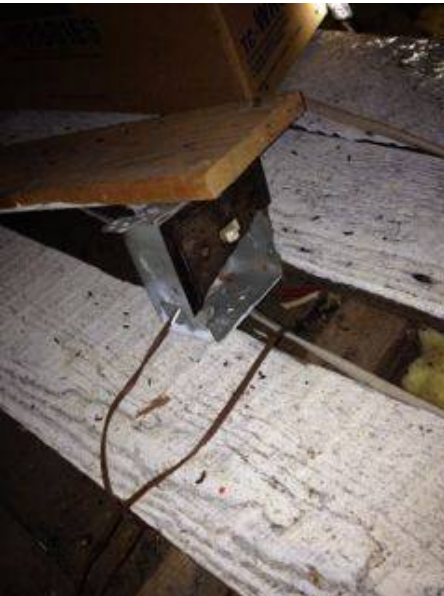
Photo 20-3

Open electrical receptacle close to attic access door. This is a safety issue.

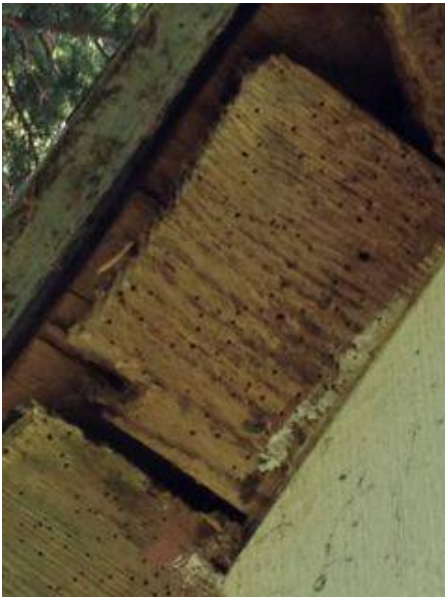
Photo 34-1
Insect holes in wood.

Evidence of past infestation of unspecified wood-destroying insects was found at eave locations in the form of holes in wood with . Recommend the following:

- Correct any conducive conditions for wood-destroying organisms mentioned in this report.
- Consult with the property owner about any history of infestation.
- Have a state-licensed pest control operator evaluate further and treat as necessary.

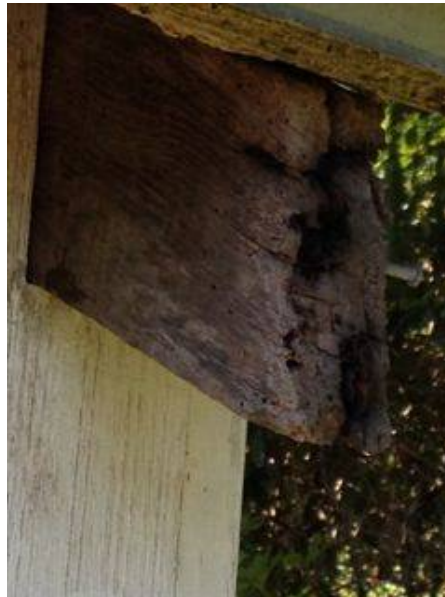
Photo 34-2
Rot and small insect holes on rafter tail.

Because of apparent cosmetic damage at location(s) #, recommend that a qualified contractor evaluate and repair as necessary. All wood significantly damaged by wood-destroying insects or fungal rot should be replaced or removed.

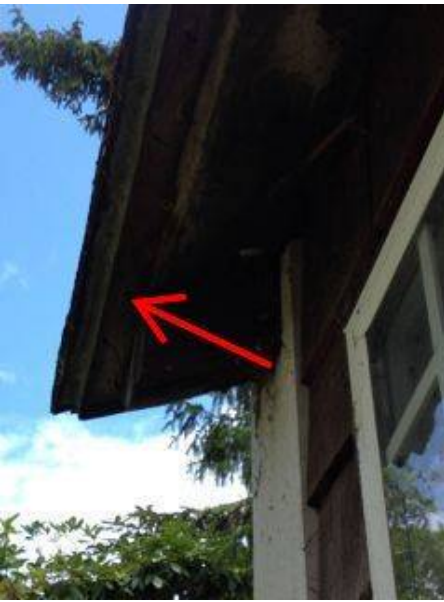
**Photo 34-3**

A white fuzzy growth on underside of roof sheathing

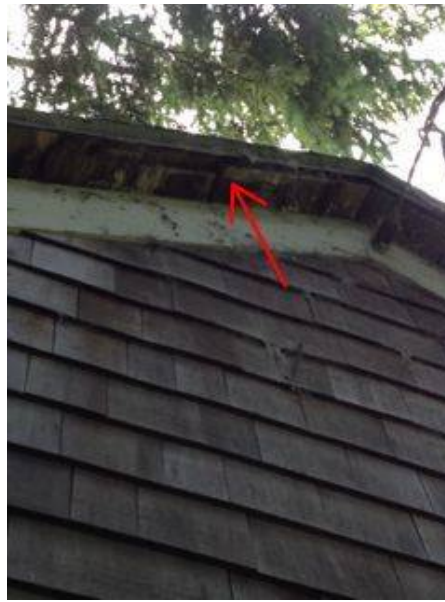
**Photo 34-4**

Rot at roof sheathing.
