Pacific Pro Home Inspection

Property Inspection Report

Property address: **Rural GB**

Inspection date: **Saturday, October 04, 2014**

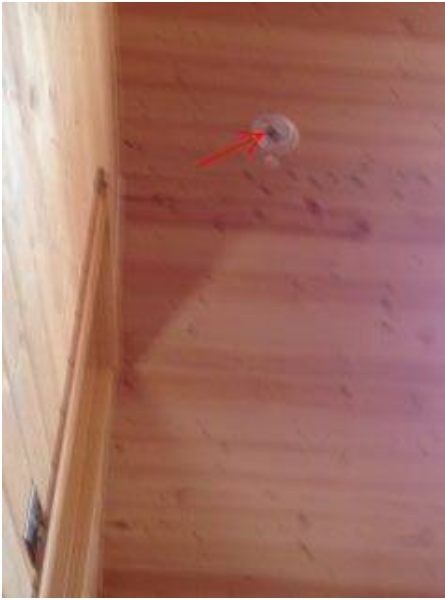
Photo 4-1
Disconnected smoke alarm

The smoke alarms have been removed probably due to extreme sensitivity. Many modern brands of smoke alarms are very sensitive to dust, animal hair, and humidity. One solution for this is to vacuum or use compressed air to blow them out once every 6 months or more often to prevent false alarms. Smoke alarms should be replaced as necessary. For more information, visit:

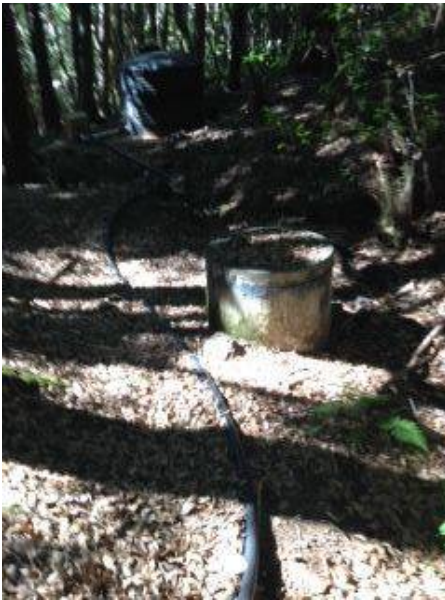
Photo 7-1

Based on visible equipment or information provided to the inspector, the water supply to this property is from a private spring with reservoir tanks and a gasoline powered pump. Private spring water supplies are specialty systems and are excluded from this inspection. Comments in this report related to this system are made as a courtesy only and are not meant to be a substitute for a full evaluation by a qualified specialist. The inspector does not test private well or spring water for contamination or pollutants, determine if the supply and/or flow are adequate, or provide an estimate for remaining life of well pumps, pressure tanks or equipment. Only visible and accessible components are evaluated. Recommend the following:

The spring fed water system

- That a qualified well contractor fully evaluate the spring fed system, including a pump/flow test
- That the spring water be tested per the client's concerns (coliforms, pH, contaminants, etc.)
- Research the spring fed systems history (how/when constructed, how/when maintained or repaired, past performance, past health issues)
- Document the current well capacity and water quality for future reference

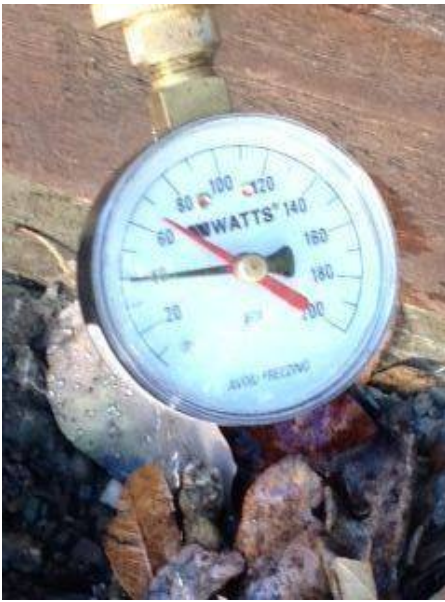
Photo 9-1
Water pressure at house. 40psi

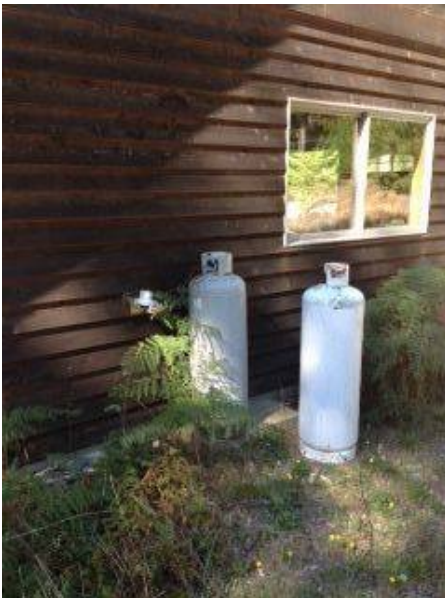
Photo 10-1
25 gallon propane tanks.

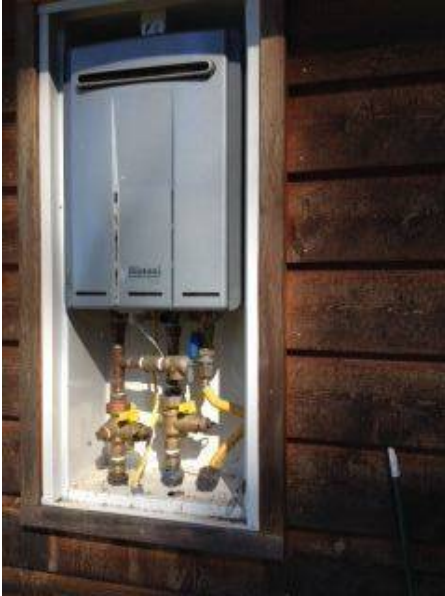
**Photo 11-1**

Rinnai on demand Propane water heater closet on back wall of house.

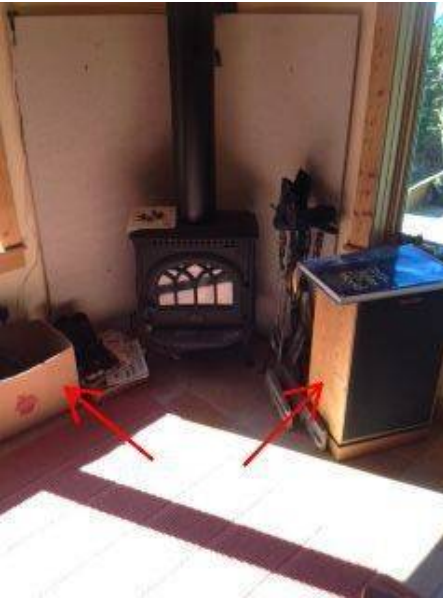
14) Stereo speaker column is sitting too close to the wood stove. Recommend at least 48" clearance.

Photo 14-1
Personal belongings too close to the wood stove.

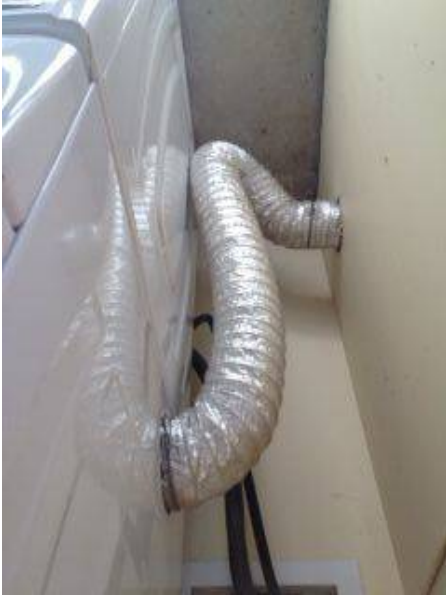
Photo 15-1

The clothes dryer was equipped with a vinyl or mylar, accordion-type, flexible exhaust duct. The U.S. Consumer Product Safety Commission considers these types of ducts to be unsafe, and a fire hazard. They can trap lint and are susceptible to kinks or crushing, which can greatly reduce the air flow and cause overheating. Recommend that such ducts be replaced with a rigid or corrugated semi-rigid metal duct, and by a qualified contractor if necessary. For more information, visit:

Mylar dryer duct

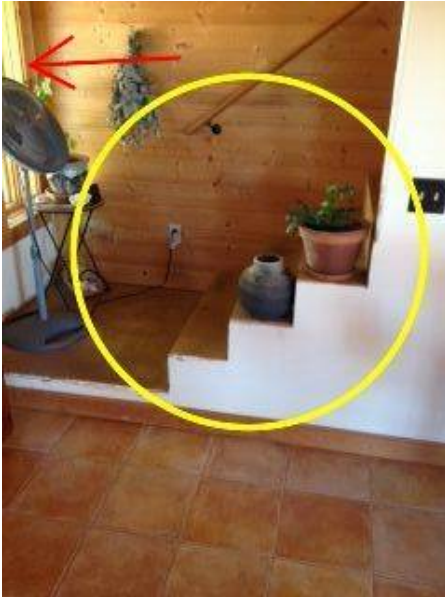
Photo 16-1

The inspector was unable to verify that the glass used in the windows at the bottom of the stairway were approved safety glass. Window glazing that is not approved safety glass, located in areas subject to human impact, is a safety hazard. Standard building practices generally require that approved safety glass be used in but not limited to the following conditions:

Red arrow is pointing to the window where safety glass is required. These stairs do have a hand grab that extends to the bottom of the treads on one side as required. While no guard rail on the open side of the stairway may have passed code (this inspection is not a code verification inspection) it is a safety concern. Also there is nothing to prevent the drywall from getting damaged due to foot kicks. Some damage exists already in a three year old house. Recommend a guardrail be built and skirting added to prevent further cosmetic damage.

Note that "art glass" (leaded, faceted, carved or decorative) may be an acceptable alternative for safety glass due to its visibility. Also, a 1 1/2-inch-wide protective bar on the accessible side of the glass, placed 34-38 inches above the floor, can serve as an acceptable substitute for safety glass. Recommend that a qualified contractor evaluate further to determine if glazing is approved safety glass, and replace glass if necessary, and per standard building practices.

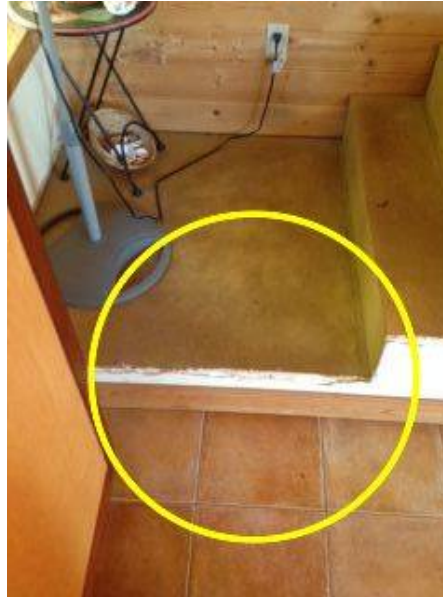
Photo 16-2

Opening at landing for stairway is less than the 36" required due to a tall cabinet placed next to landing. This could be a safety issue as well as an inconvenience. Recommend moving the cabinet.
